BRIDGE CONDITION REPORT

STRUCTURE NUMBER: 084-0107 (NB)
084-0108 (SB)

LOCATION: I-55 OVER BRUSH CREEK

DATE PREPARED: NOVEMBER, 2003

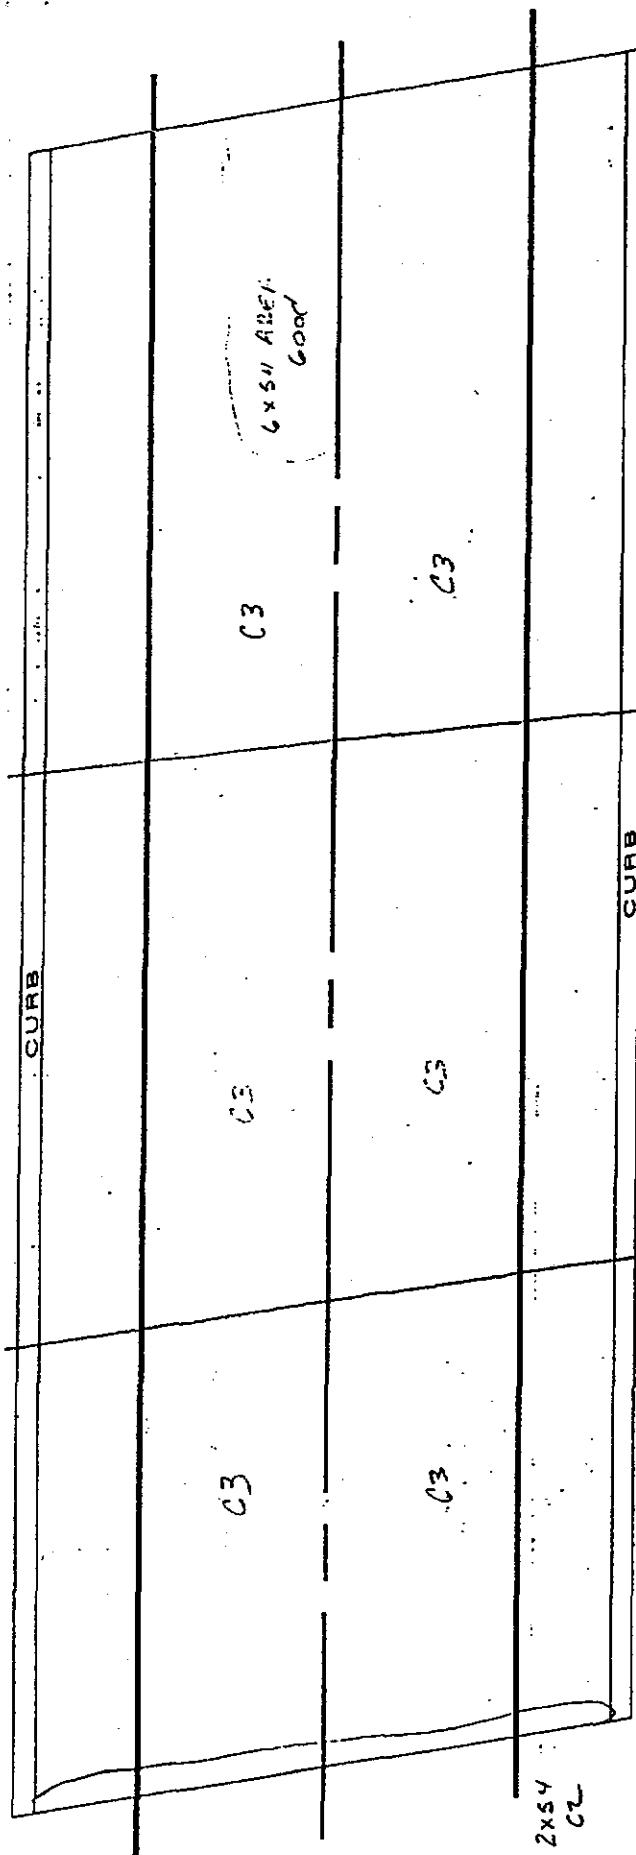
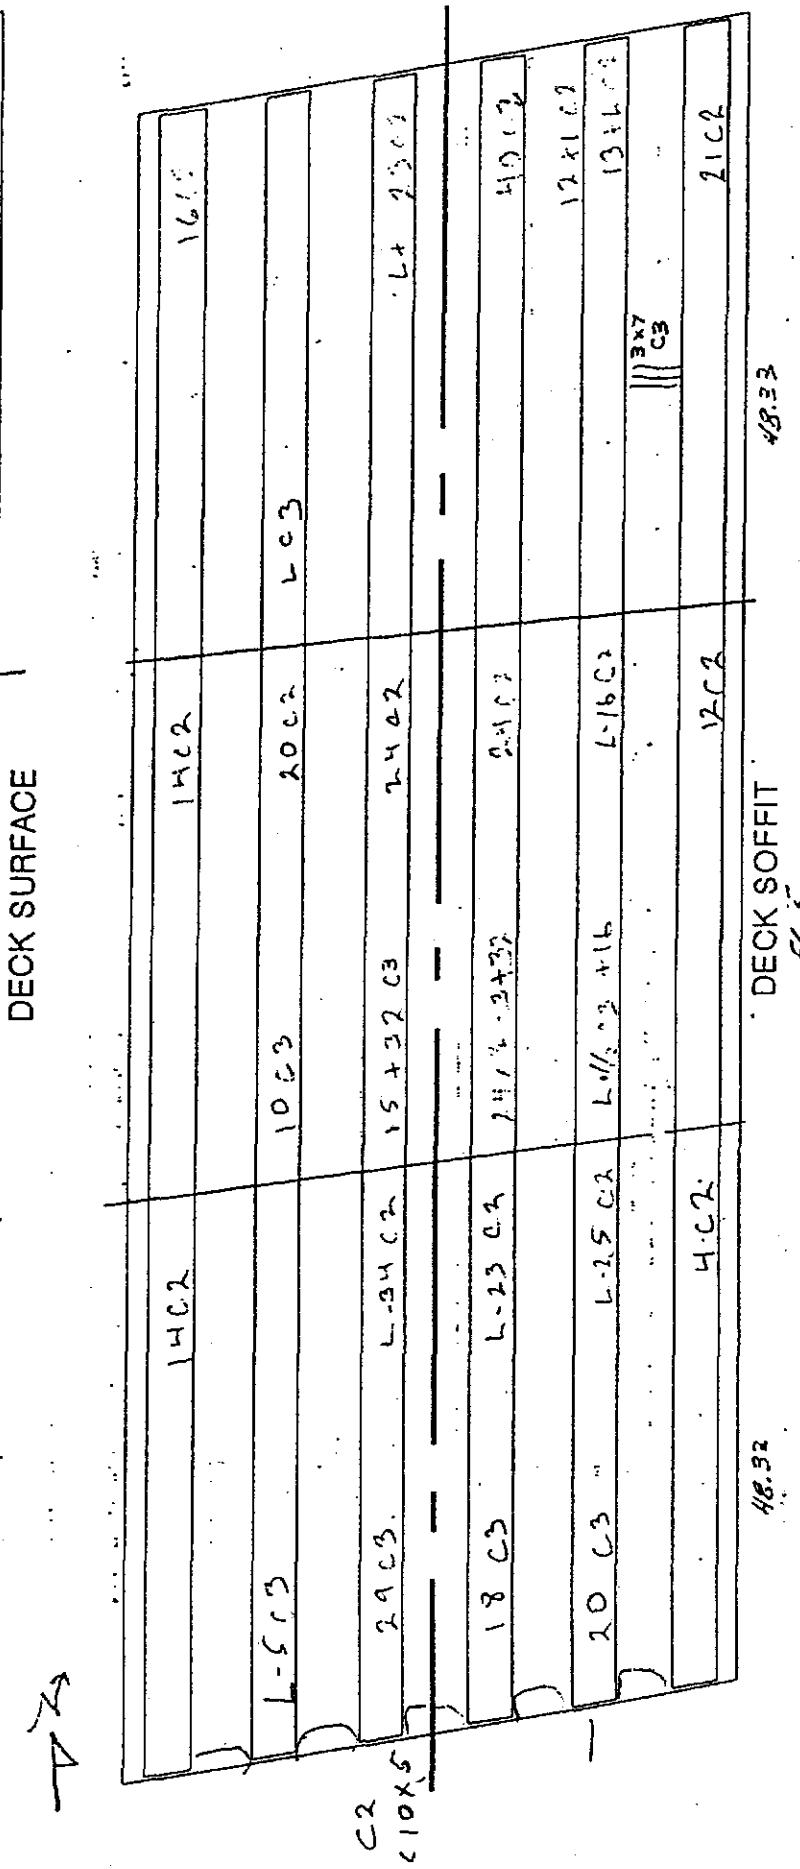
SIRHCUHE NO. 084-0107

Bld. Wearing Surface has heavy map cracking throughout.

North exp. Joint is in poor condition, with $\pm 12'$ showing damaged blocks. Joint has mod. leakage.

concrete parapets show light hairline vertical cracking. Alum rails are in good condition.

Deck soffit has minor hairline transverse cracking throughout. Good Condition. Minor delaminations around a few drains.

steel beams show light to moderate rusting on interior beams. Repainted beam ends look good.

North abut. backwall has light map cracking at both wing jet. Some scaling noted at west wing jet. (1) horizontal crack noted in top portion of the cap.

South abut. backwall/wing jets show light map cracking. Light scaling noted at west jet.

* 12 drain extensions missing at south abut.

* North exp. Jt damaged Neoprene blocks torn ± 12 LF (loose)

- Remove the bituminous wearing surface and waterproof membrane system and replace with 2 ¼" minimum microsilica wearing surface. It is estimated that there will be 10 sq. yd. (1.3%) of full depth patching and 30 sq. yd. (4%) of partial depth patching.

- Replace the bearings at both abutments.
- Remove the neoprene expansion joint seals and hold down blocks at both abutments. The concrete adjacent to the joint at the end of the deck and on the approach needs replaced at the north abutment only. Install polymer nosing and silicone joint sealer at both abutments.

- Plug every other deck drain and drains over substructure units. Replace missing drain extensions if not plugged and add support to bottom flange of fascia beam on all extensions to remain in place.

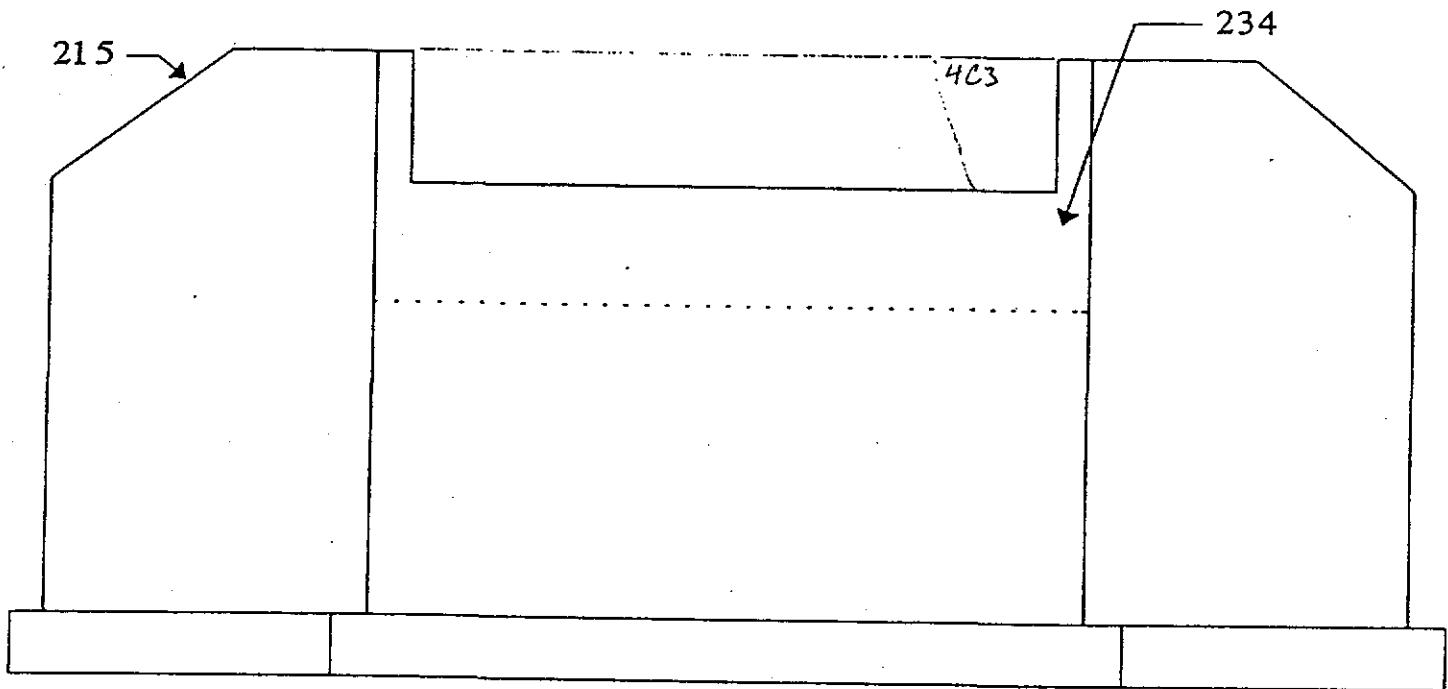
NORTH ABUTMENT

North abut backwall has minor hairline vertical cracking. Channel alignment good.

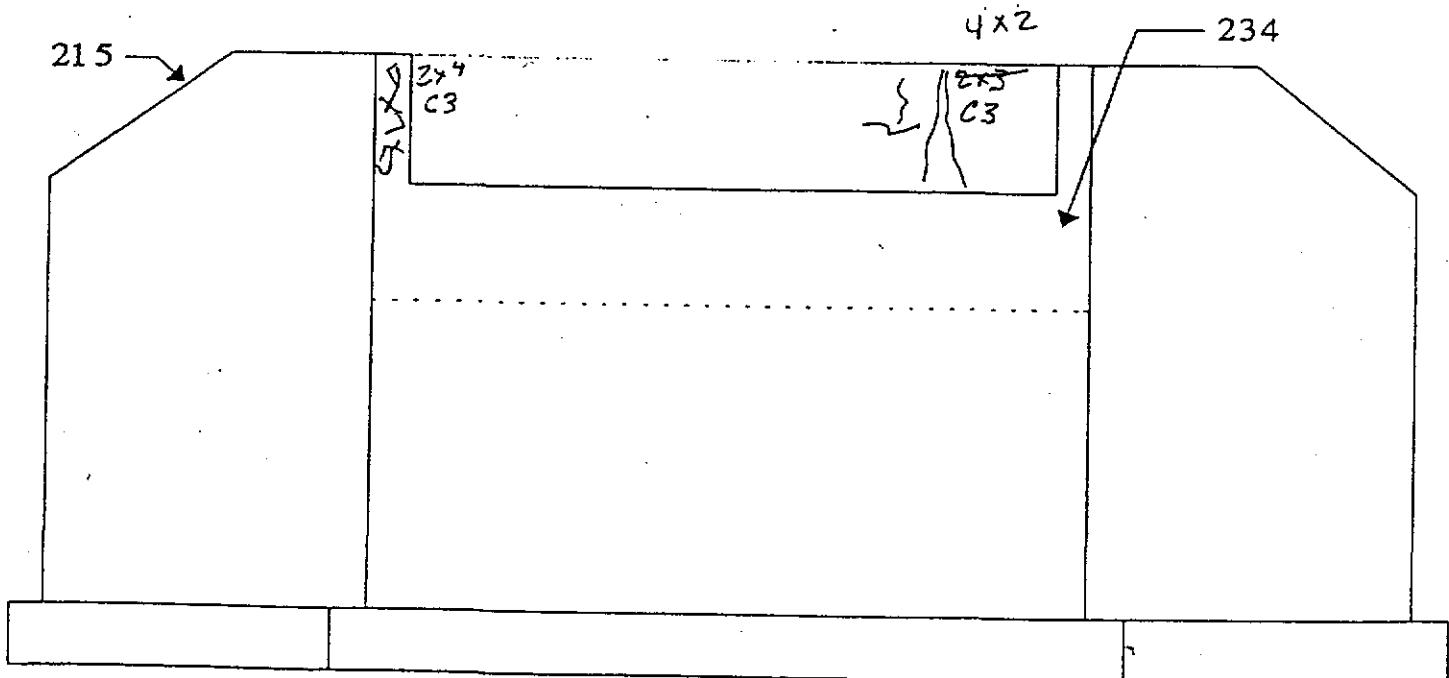
SCRUB ABUTMENT

South abut neoprene joint has $\frac{1}{2}$ section missing near E.

South abut backwall has light map cracking with effl. leaching.
